**LETTER REPORT
FOR
EGAN-MARINE SITE
LEMONT, COOK COUNTY, ILLINOIS
TDD No.: T05-9501-003
PAN: EIL0852CBA**

MARCH 22, 1995

**Prepared for:
UNITED STATES ENVIRONMENTAL PROTECTION AGENCY
Emergency and Enforcement Response Branch
77 West Jackson Boulevard
Chicago, Illinois 60604**

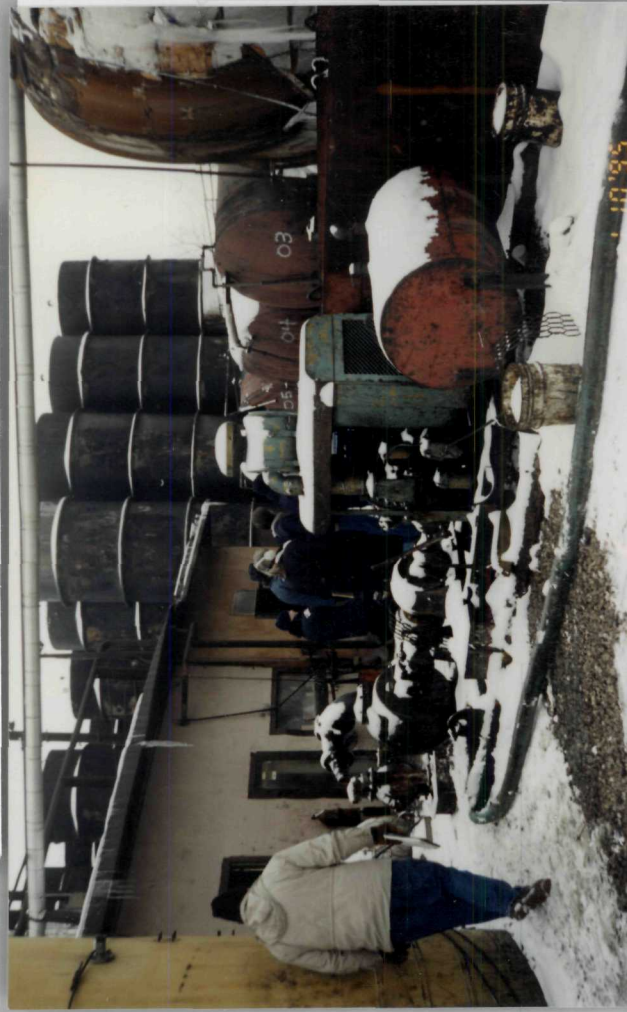
SITE: Egan Marine TDD #: T05-9501-003 DATE: 1/10/95
 PHOTO #: 4 DIR: WSW PHOTOGRAPHER: Rydzewski
 DESCR: Pump used for draining shallow pit area. Pump
 is located next to maintenance building.

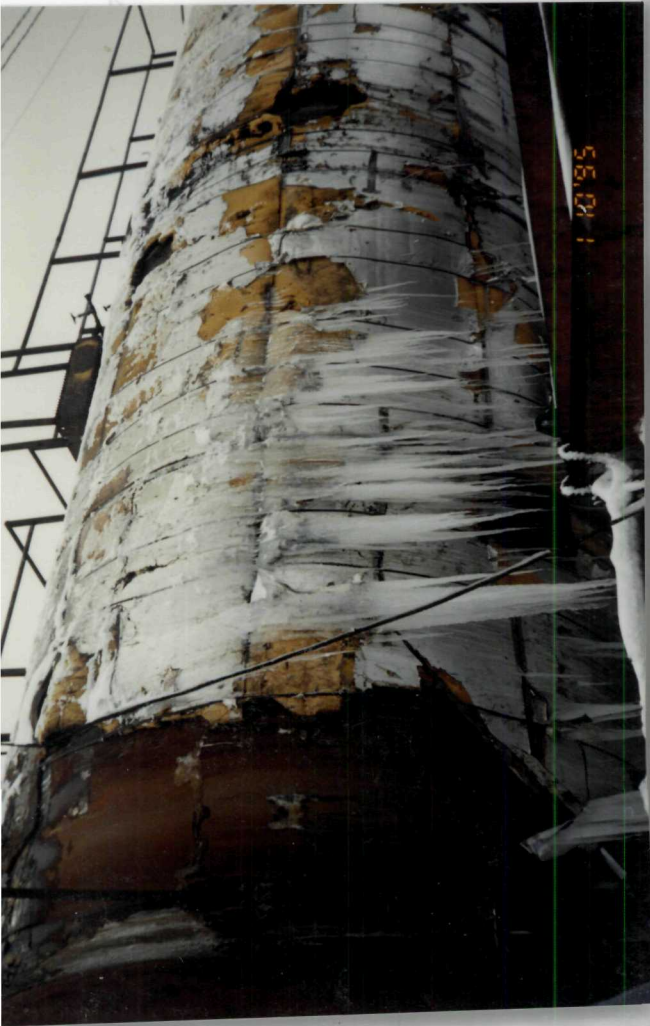
SITE: Egan Marine TDD #: T05-9501-003 DATE: 1/10/95
 PHOTO #: 5 DIR: N PHOTOGRAPHER: Rydzewski
 DESCR: Deteriorated condition of 25,000 gallon vegetable oil tank which is next to oil/water separator.

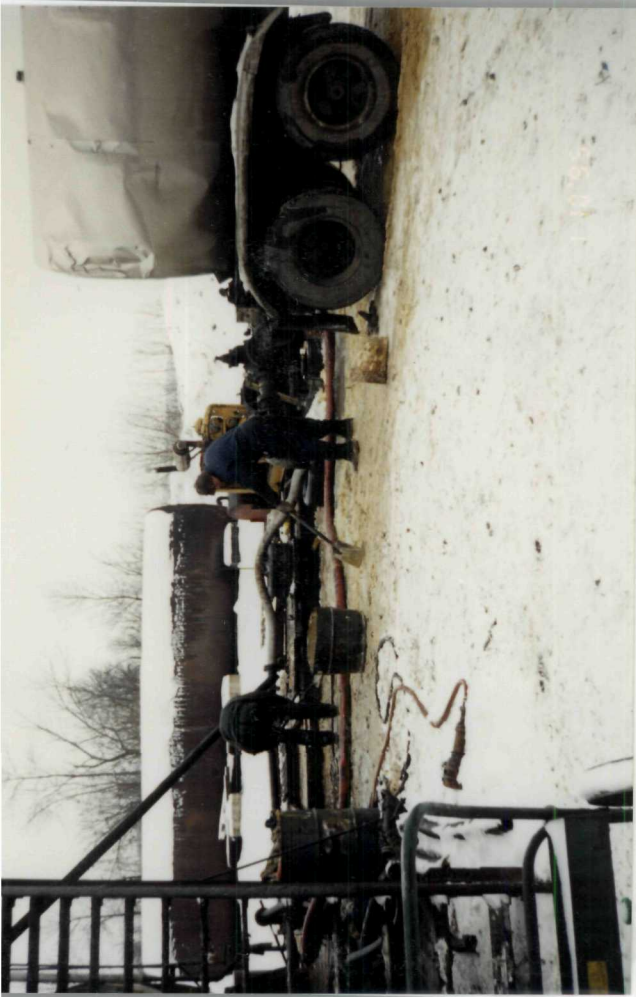
SITE: Egan Marine TDD #: T05-9501-003 DATE: 1/10/95
 PHOTO #: 13 DIR: SW PHOTOGRAPHER: Rydzewski
 DESCR: Egan Marine employees scraping and removing spilled vegetable oil after an unloading event.

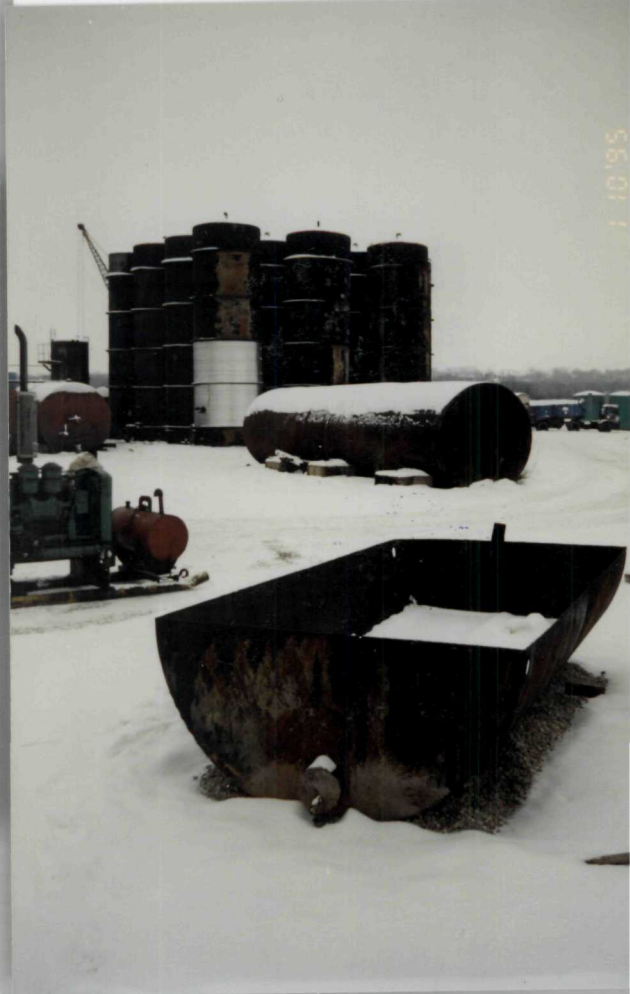
SITE: Egan Marine TDD #: T05-9501-003 DATE: 1/10/95
PHOTO #: 20 DIR: SE PHOTOGRAPHER: Rydzewski
DESCR: View of inside of half tank. A pipe, located
in the middle, was used as a source to heat
oil.

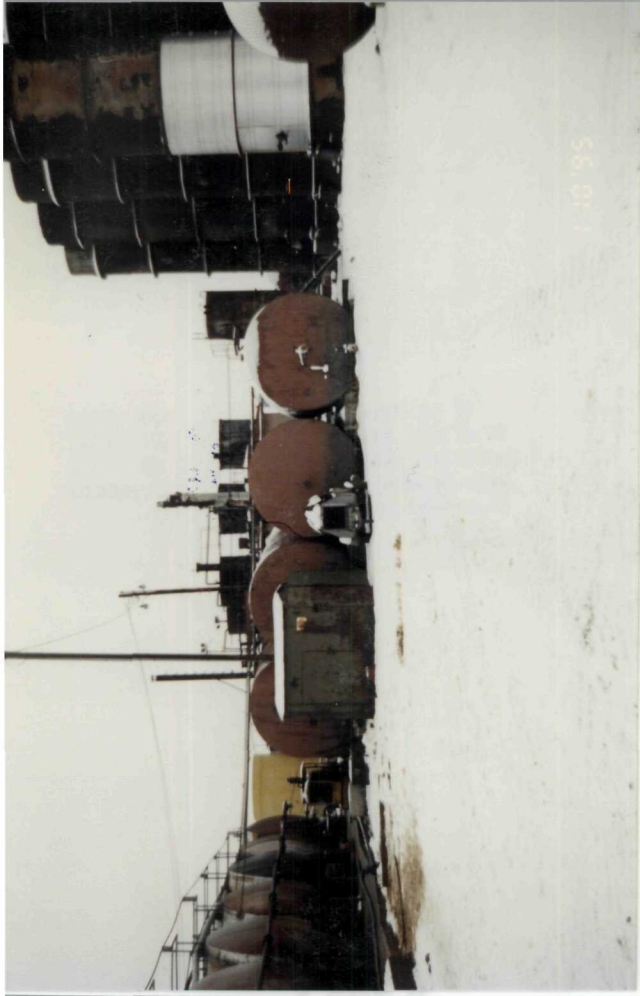
SITE: Egan Marine TDD #: T05-9501-003 DATE: 1/10/95
 PHOTO #: 21 DIR: SE PHOTOGRAPHER: Rydzewski
 DESCR: Vegetable oil tanks located in the shallow pit area.

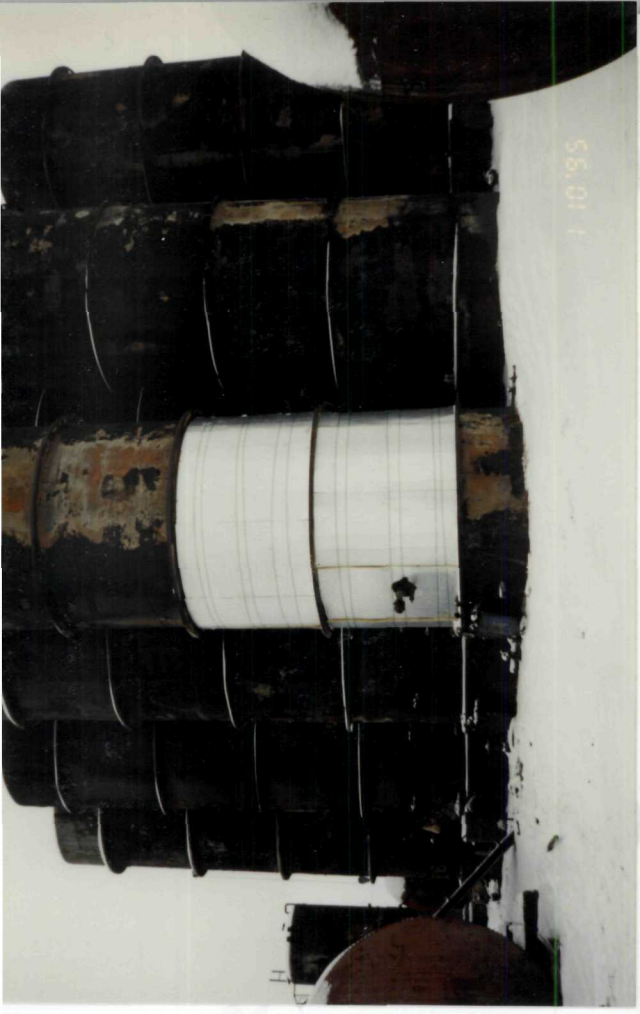
SITE: Egan Marine TDD #: T05-9501-003 DATE: 1/10/95
 PHOTO #: 22 DIR: SSE PHOTOGRAPHER: Rydzewski
 DESCR: Vegetable oil tanks which formerly were diesel oil tanks. Note tank condition and lack of berm.

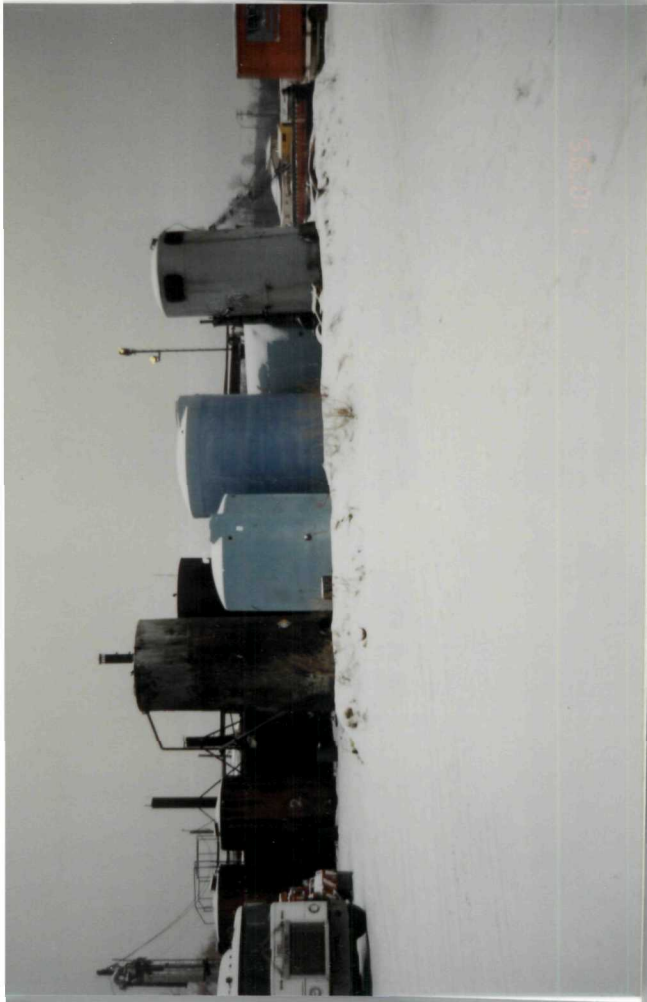
SITE: Egan Marine TDD #: T05-9501-003 DATE: 1/10/95
 PHOTO #: 31 DIR: NNE PHOTOGRAPHER: Rydzewski
 DESCR: Breach in berm near poly tanks and diesel and asphalt tanks.

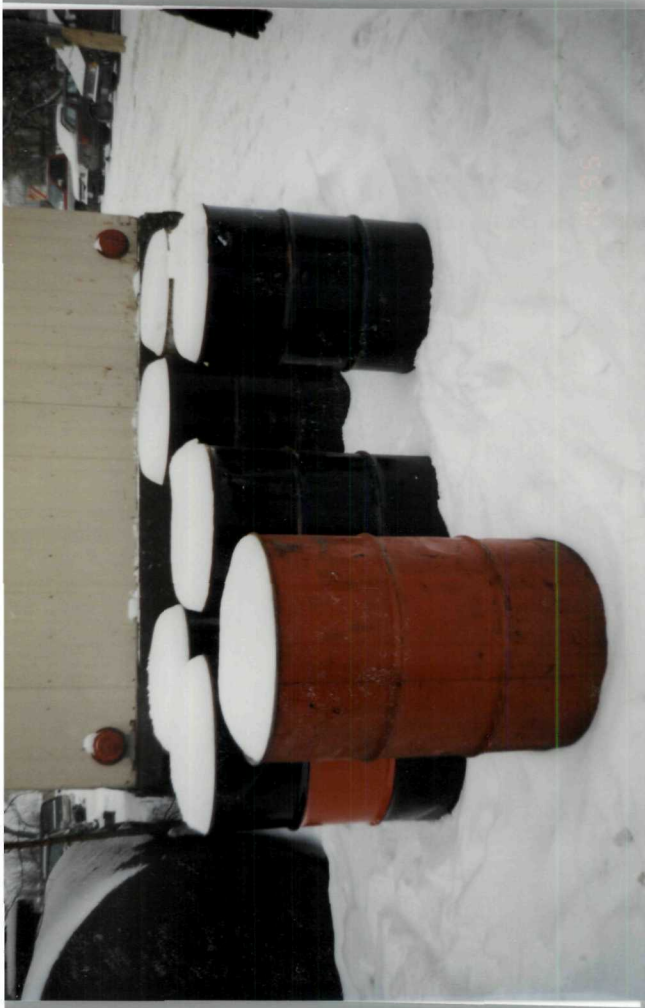
SITE: Egan Marine TDD #: T05-9501-003 DATE: 1/10/95
 PHOTO #: 39 DIR: W PHOTOGRAPHER: Rydzewski
 DESCR: Unmarked drums next to mobile trailer and office.

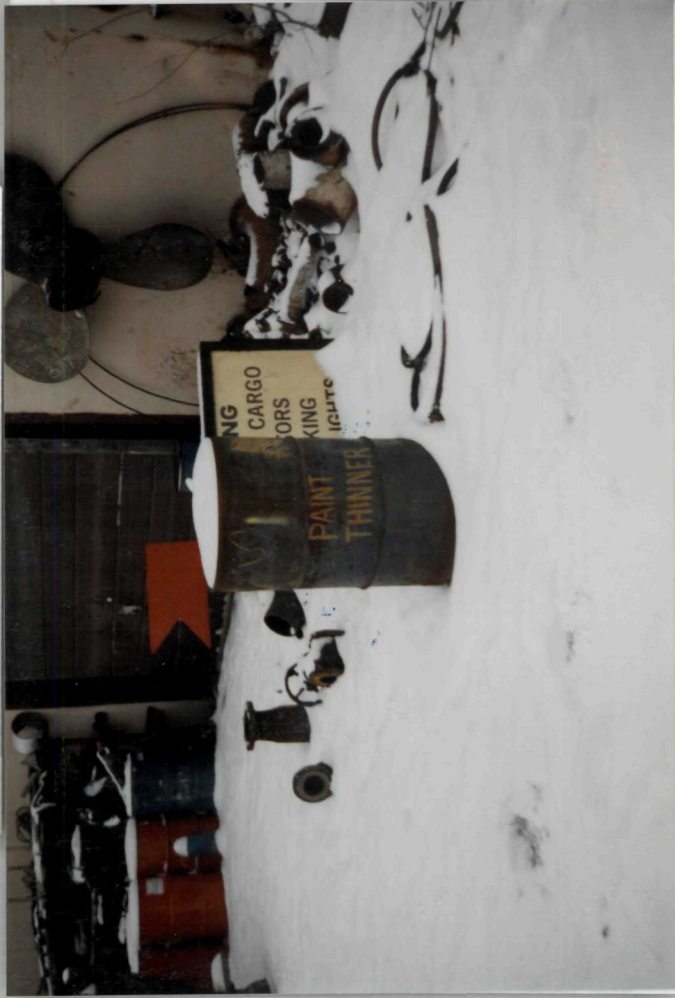
SITE: Egan Marine TDD #: T05-9501-003 DATE: 1/10/95
 PHOTO #: 45 DIR: E PHOTOGRAPHER: Rydzewski
 DESCR: Drums stored under pole shed on eastern
 peninsula. Note lack of secondary
 containment.

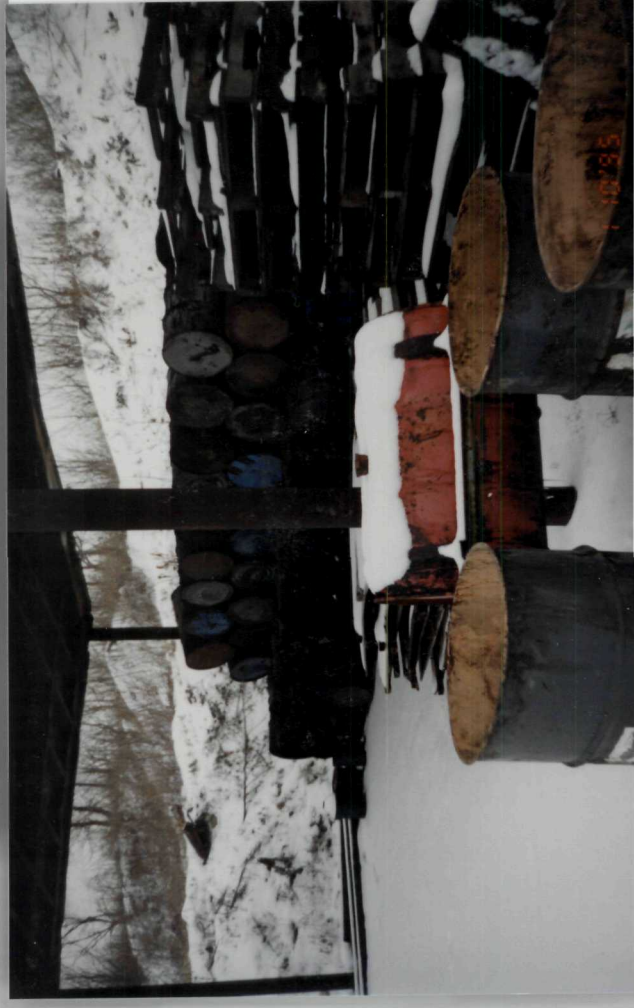
SITE: Egan Marine TDD #: T05-9501-003 DATE: 1/10/95
 PHOTO #: 46 DIR: NE PHOTOGRAPHER: Rydzewski
 DESCR: Close-up view of drums stored under pole shed.
 Note empty drums.

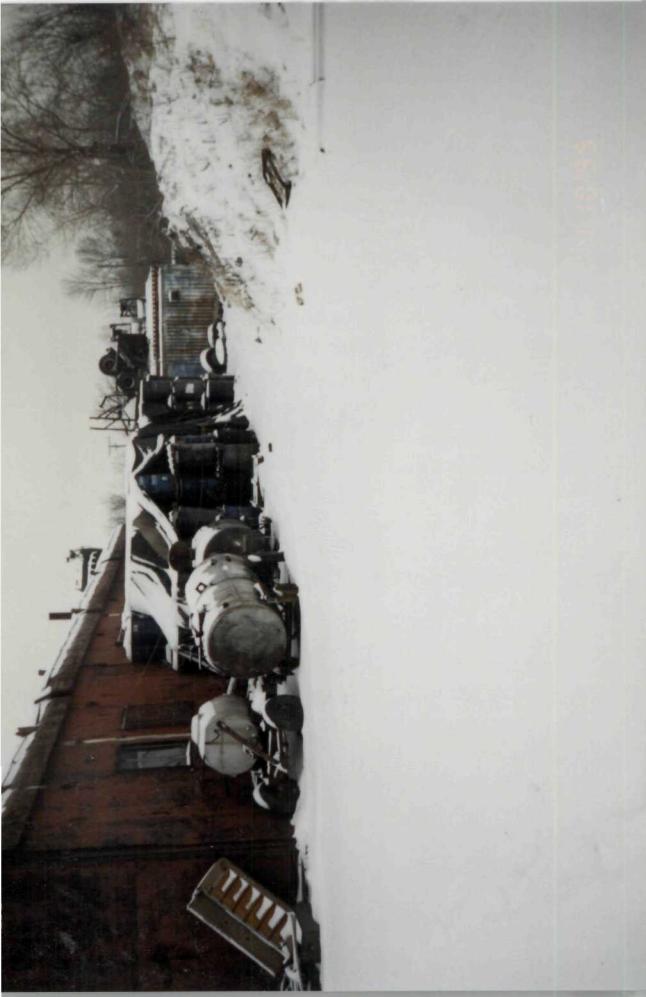
SITE: Egan Marine TDD #: T05-9501-003 DATE: 1/10/95
 PHOTO #: 47 DIR: N PHOTOGRAPHER: Rydzewski
 DESCR: Stacked 55-gallon drums of vegetable oil behind scrap storage shed. Drums have no containment.

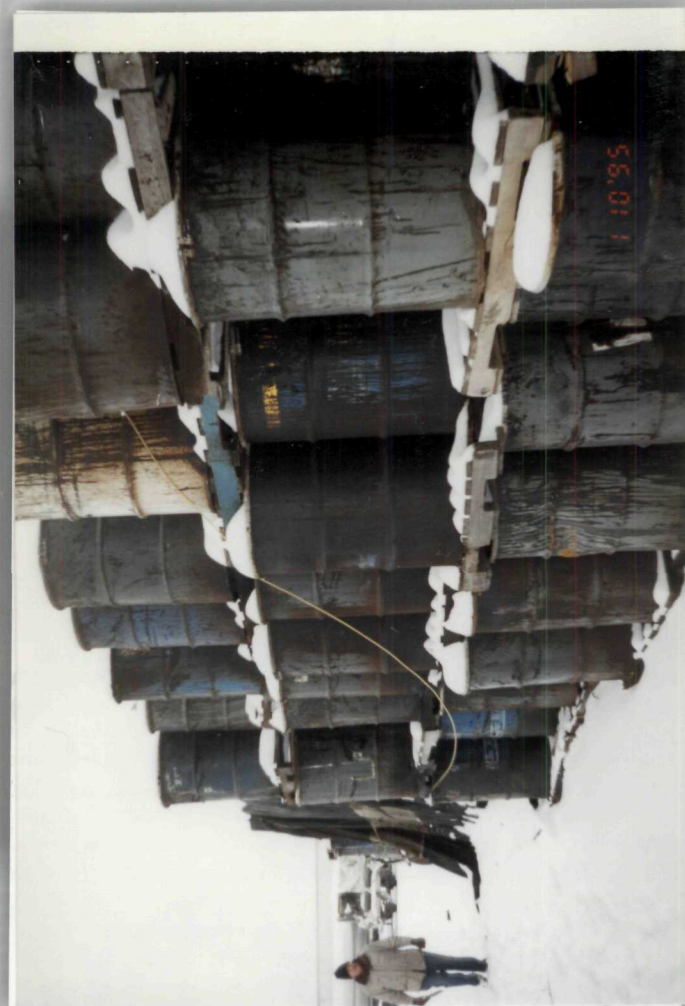
SITE: Egan Marine TDD #: T05-9501-003 DATE: 1/10/95
 PHOTO #: 50 DIR: S PHOTOGRAPHER: Rydzewski
 DESCR: 55-gallon drums stacked next to scrap storage shed. Note condition of drums.

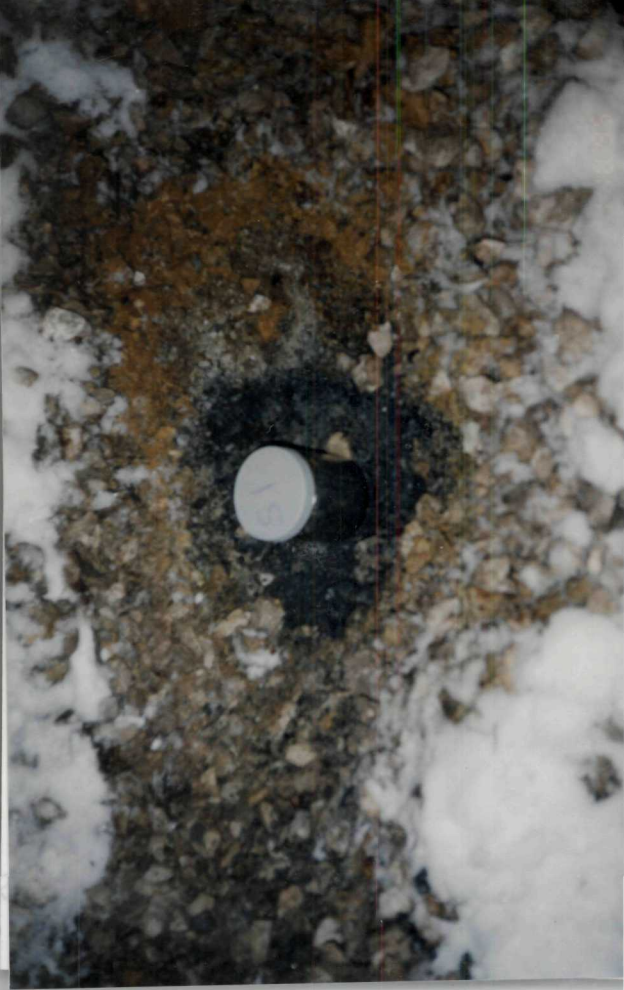
Sample analysis detected levels of TPH as diesel fuel in all four samples. Sample S1 contained 1,180 milligrams per kilogram (mg/kg) TPH as diesel fuel, sample S2 contained 2,130 mg/kg, sample S3 contained 157,000 mg/kg, and sample S4 contained 4,390 mg/kg. All samples also contained less than 20 mg/kg of TPH as gasoline and oil. The data and quality assurance review can be found as Attachment B.

SITE: Egan Marine TDD #: T05-9501-003 DATE: 1/10/95
PHOTO #: 62 DIR: SE PHOTOGRAPHER: Rydzewski
DESCR: Close-up view of sample location S1 taken
between the 27,000 gallon vegetable oil tanks.
